UNCATALOGED CREEK 1 ADDITION

Stream: Uncataloged Creek 1

Watershed: Salamander Creek-Frontal Eastern Passage

MTRS: C062S084E, Petersburg B-2 **Date Surveyed:** August 14, 2013

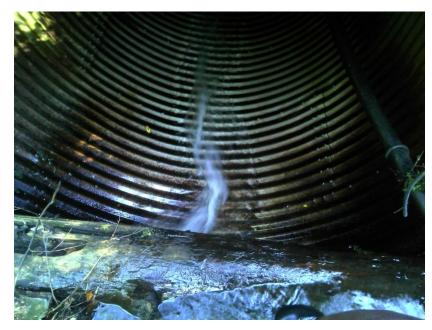
Findings: We surveyed this uncataloged stream and caught coho salmon using an electrofishing unit. The stream bed is perched above the upstream side of the culvert with an intake line going through (Figure 1) and there is a steep channel barrier (Figure 2) above the culvert (Table 1 and Figure 3).

Figure 1.—Perched stream with intake line.

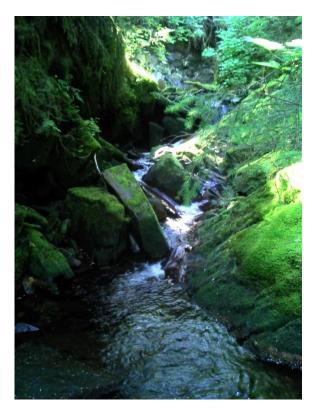
Figure 2.—Channel barrier.
